Improved Guardrail Terminal

Development of a BEST Terminal to Comply with NCHRP 350 Requirements

**December 1998
Final Report**

NCHRP Report 350 Compliance Testing of the BEST System

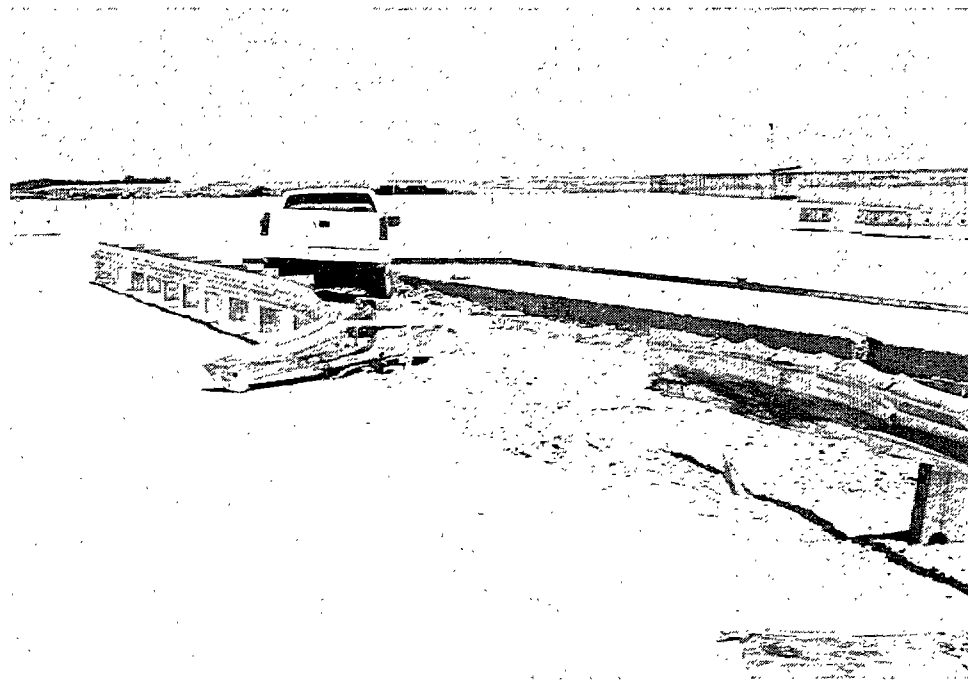
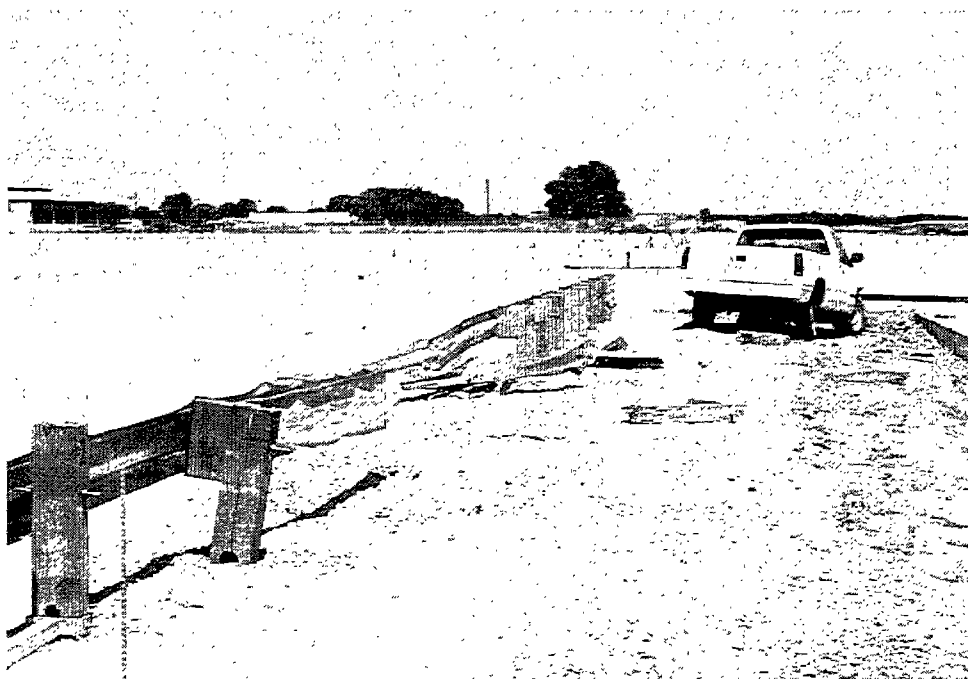
Figure 15. Post-test photographs of Test BEST-2.

The cable anchor system performed well during this test, as the tab system supported the full load of the redirection impact. However, the posts did not rotate normally, and broke off at the groundline before providing an adequate redirection force to the vehicle. This behavior resulted in the pickup continuing into the system further than is normally observed, causing pocketing to occur, and ultimately resulting in the rupture of the W-beam guardrail. After this failure occurred, the vehicle continued through the system and came to rest behind the guardrail. Post-test photos of this system are presented in Figure 15.

After reviewing the high-speed film from this test, it was evident that the primary reason for the failure of the system was the fact that the posts fractured prematurely. This phenomenon was investigated through bogie testing of similar posts under comparable conditions, and several discoveries were made. The first and most significant finding was that the placement of the post next to the 610 cm (24 in.) deep concrete apron significantly affected the soil resistance and contributed to the early failure of the posts. A second contributing factor was that the CRT posts used for this system were 140 mm x 190 mm (5½ in. x 7½ in.) finished posts instead of the standard 152 mm x 203 mm (6 in. x 8 in.) rough cut. This resulted in a reduction in the post

section modulus of approximately 22 percent. As a result of the bogie testing, a revised post design was developed that utilized 152 mm x 203 mm (6 in. x 8 in.) rough cut posts and a total length of 1778 mm (5 ft - 10 in.). The post's embedment depth was thereby cut to 1067 mm (42 in.) which was expected to reduce the soil forces on the post by approximately 10 percent in order to assure that the posts would rotate without fracturing, even under tight soil conditions. The problems associated with installing the guardrail adjacent to the concrete apron were also addressed moving the front face of an additional 1.5 m (5 ft) from the concrete.

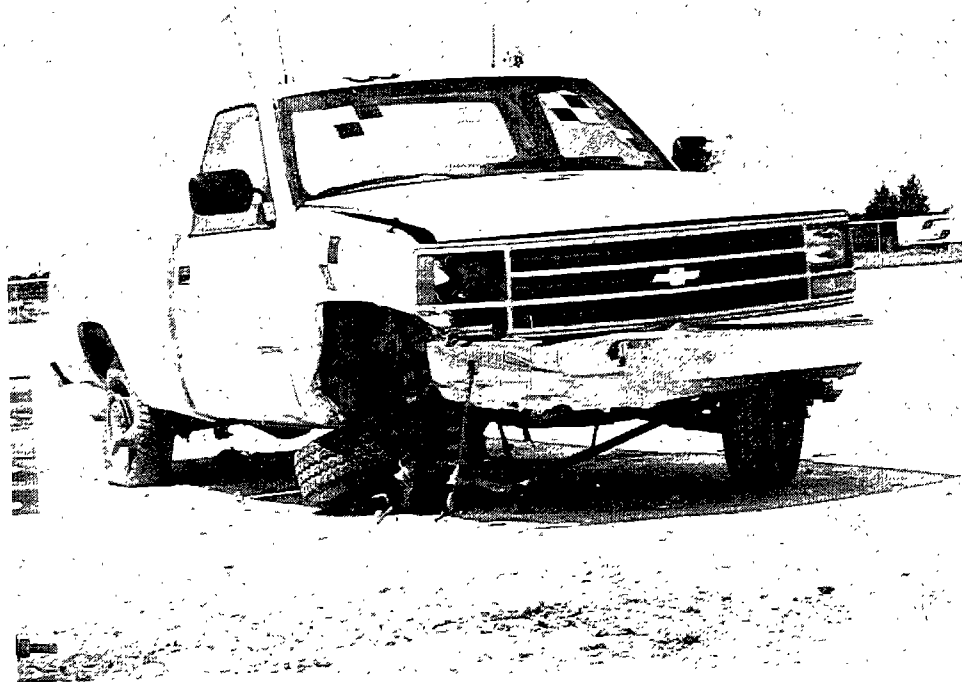
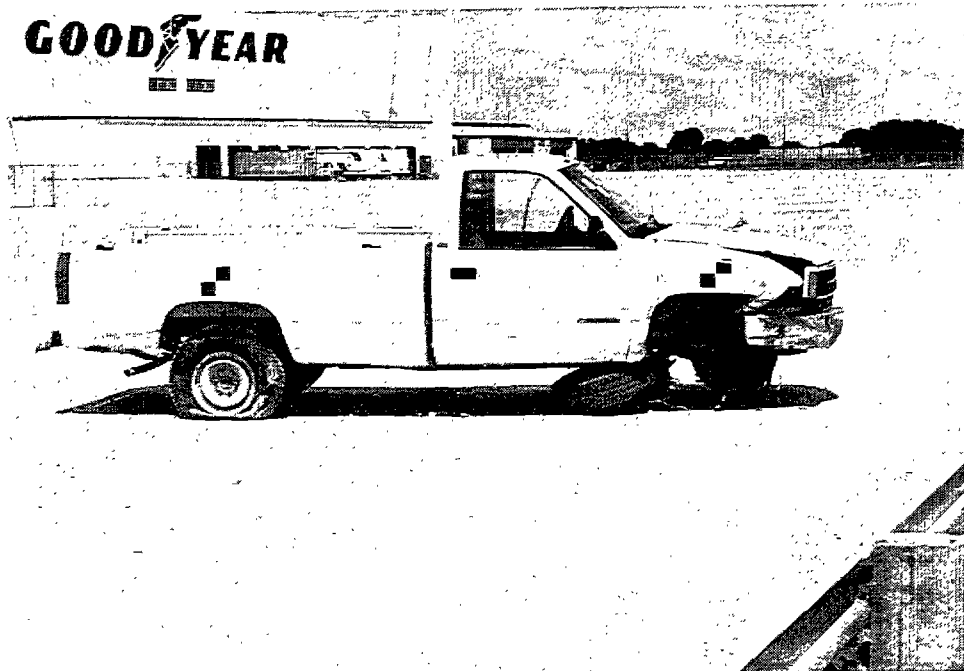
Figure 20. Vehicle Damage, Test BEST-3.

Damage to the vehicle was minor considering the severity of the impact conditions, as shown in Figure 20. The right-front corner of the vehicle was damaged and the wheel assembly was disengaged from the vehicle. Minor contact damage continued down the side of the vehicle and the right-rear tire was torn. There was only very minor deformation of the passenger compartment (13 mm (½ in.) on the firewall on the passenger side) and the windshield remained undamaged.

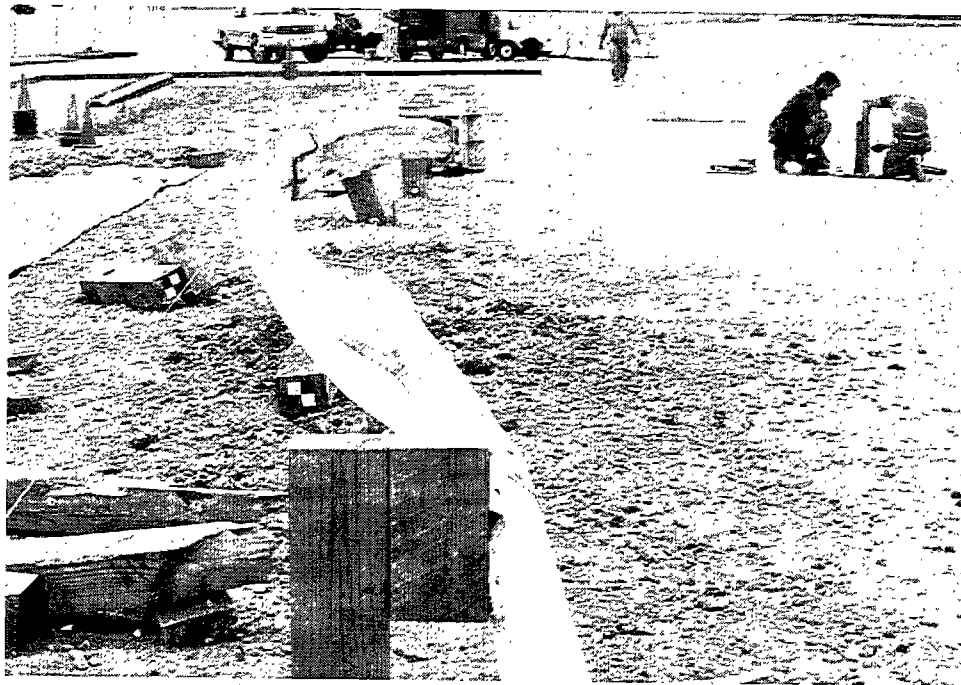
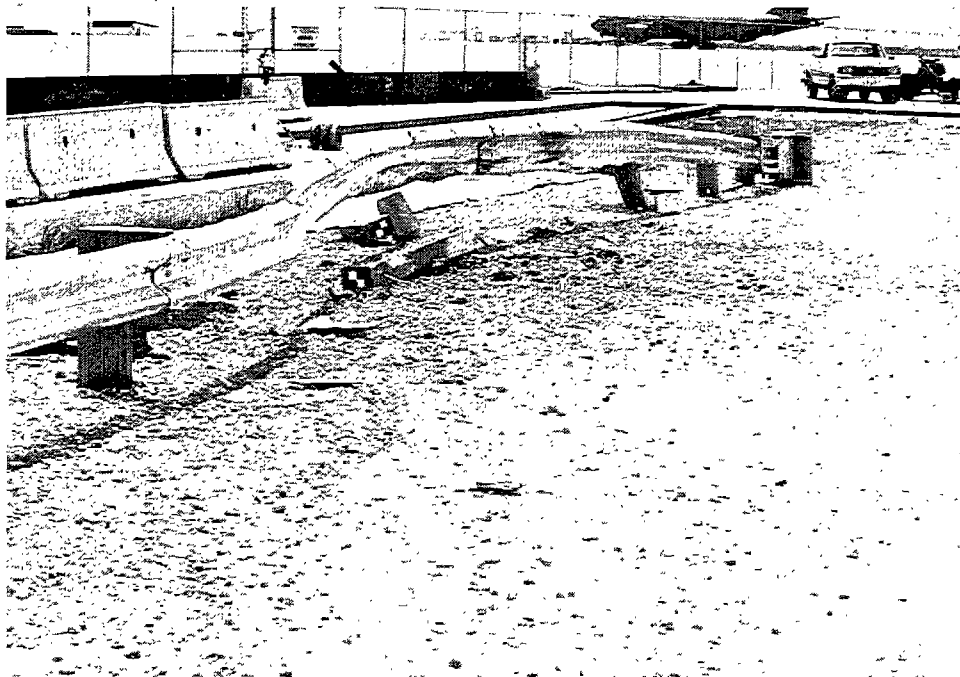
Figure 21. Installation damage, Test BEST-3.

Damage to the system, shown in Figure 21, included the rotation and subsequent fracture of post No. 3 at the top CRT hole. Post Nos. 4 and 5 rotated and fractured at the bottom hole, while post No. 6 rotated and was uprooted without breaking. Post No. 7 rotated and failed at an

angle, with the fracture passing through both of the CRT holes. Post No. 8, which was not a CRT post, failed at the groundline, and there was no measurable damage to or deformation of the remaining posts. The total length of contact was approximately 11 m (36 ft), as the last point of contact was 610 mm (2 ft) upstream of post No. 9. There was no sign of damage to the cable anchor box, but a number of the W-beam tabs showed evidence of high loads. The maximum permanent deformation in the rail was 758 mm (29.8 in.) at post No. 6.

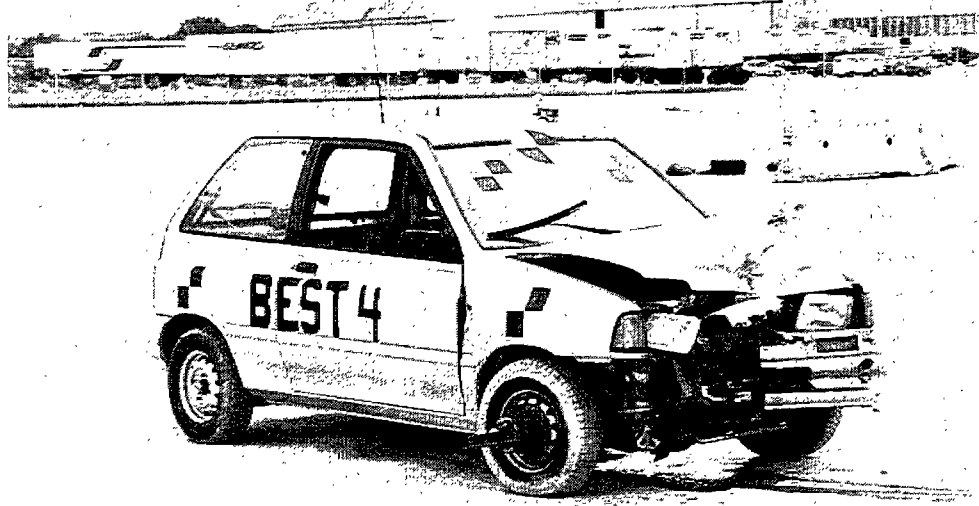
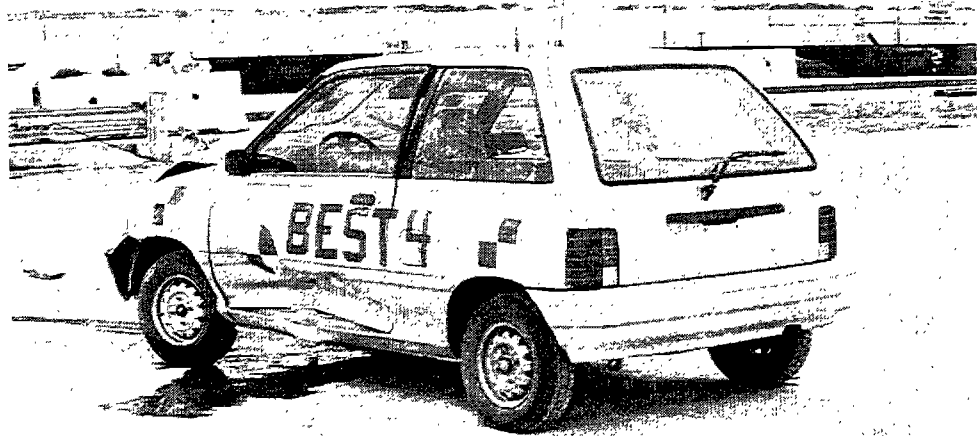
Figure 26. Vehicle Damage, Test BEST-4.

Damage to the vehicle, shown in Figure 26, included approximately 267 mm (10.5 in.) of

front end crush resulting from the contact with the impact head. There was also approximately 76 mm (3 in.) of deformation on the outside of the drivers door resulting from contact with the W-Beam as the vehicle passed by it after losing contact with the head. This resulted in 25 mm (1 in.) of deformation on the inside of the driver's side door. There was only minor deformation of the vehicle floorboard, and the windshield was cracked on the lower driver's side corner.

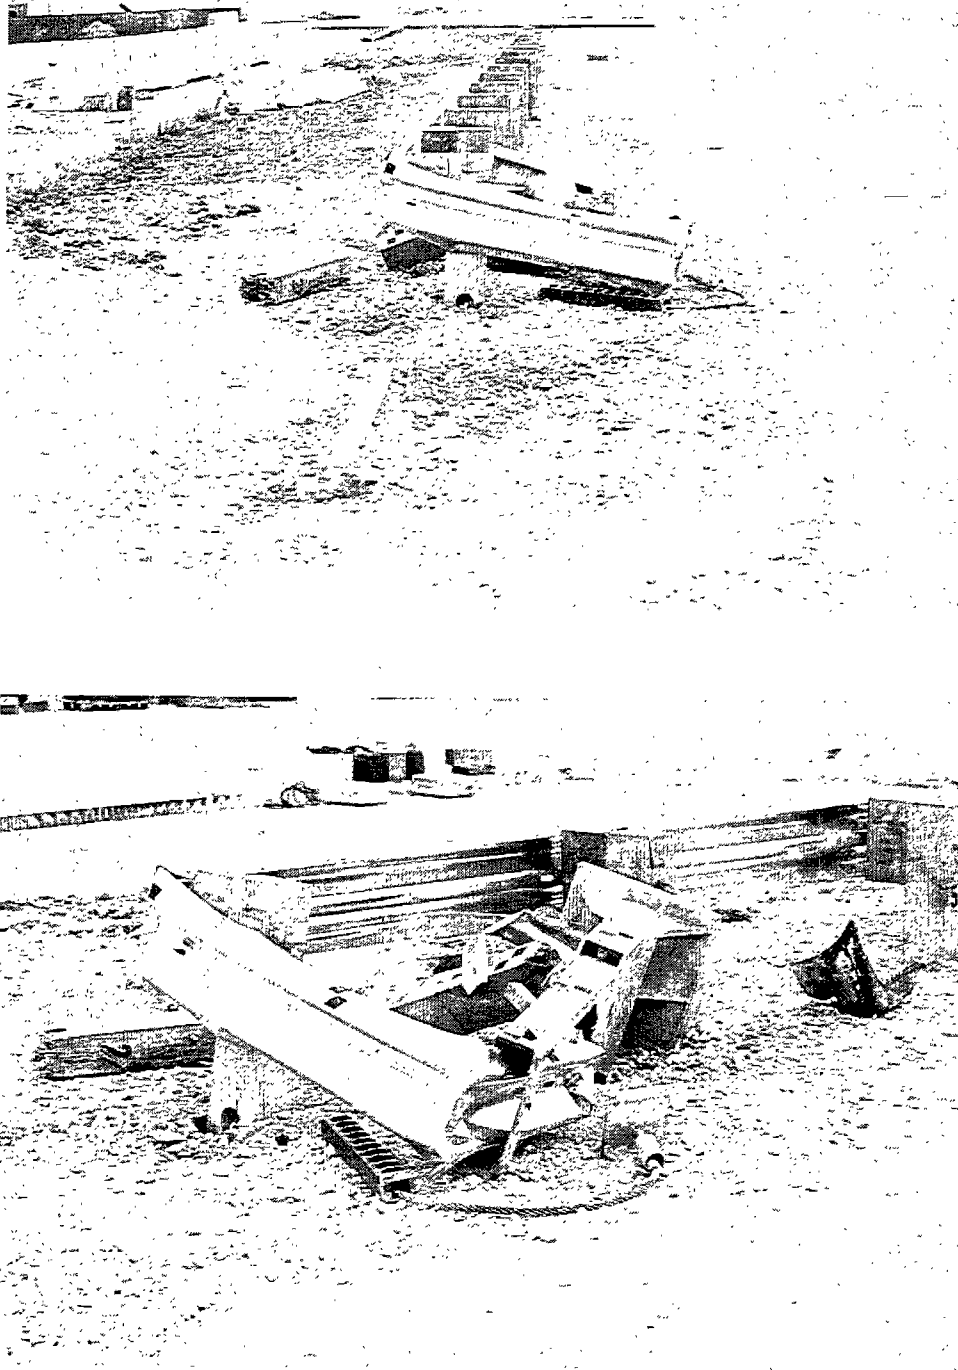
Figure 27. Installation damage, Test BEST-4.

The damage to the system is shown in Figure 27. The head cut through 1.28 m (4 ft - 2 ¼ in.) before the system buckled out of the path of the vehicle. Post Nos. 1 and 2 were fractured at the groundline, and post No. 3 rotated downstream slightly as a result of contact with the deformed W-Beam. The remainder of the posts were left virtually untouched.

Although test BEST-4 was successful, there was a concern that the observed deformations of the post breaker block could slow the process of breaking the leading post and allow the feeder chute to strike the cable anchor bracket before the other end of the cable was released. Therefore, the impact head was modified after test BEST-4 by adding a brace to the post breaker to prevent it from being bent back upon impact with a post.

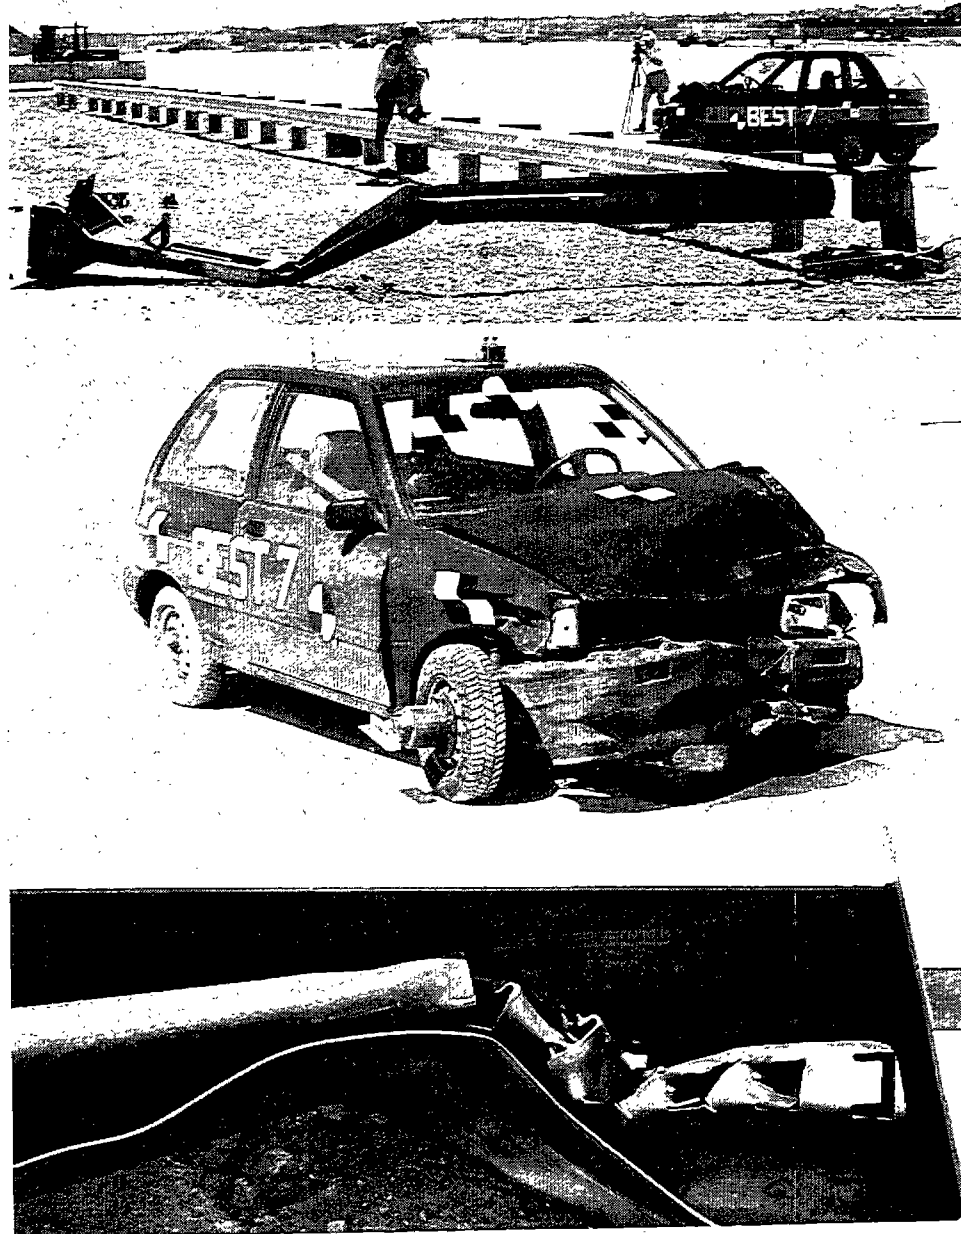
Figure 30. Post-test Photographs of Test BEST-7.

Damage to the vehicle was acceptable, as shown in Figure 30, with 25 cm (10 in.) of crush in the front of the vehicle and a maximum of 73 mm (2⁷/₈ in.) internal occupant compartment deformation occurring on the front floorboard.

There was significant deformation of the W-beam rail, as shown in Figure 30. The bottom of the rail was deformed from contact with the end of the chute. The cutting path showed that the blades started cutting in a sharply upward manner almost immediately after impact. When the head was removed from the rail, there was noticeable wear on the cutting blades. The first three posts broke away cleanly, and the rail buckled at the midspan between post nos. 2 and 3 and at

post no. 4. There were also contact marks on the groundline strut and second foundation tube which indicated that the undercarriage of the vehicle had contacted these terminal components.

Since this type of behavior had not been seen in any of the previous bogie or full-scale tests, which had all been conducted on galvanized W-beam, it was decided to perform a series of static and dynamic tests to determine the affect that galvanizing had on the behavior of the system. These tests showed that the system does perform differently on galvanized and non-galvanized W-beam. The bogie tests on galvanized W-beam produced a steady state cutting force of approximately 10 to 12 kips, while the tests on the non-galvanized rail produced a force which started out around 10 kips and climbed quickly to approximately 20 kips throughout the cutting process. This behavior was attributed to the wearing of the cutting blades which was evident after each bogie and full-scale test on ungalvanized beam. The cutters, which are fabricated from abrasion resistant steel and then galvanized, have shown no signs of wearing in all of the tests conducted previously with galvanized W-beam. It was also noted that the cutter teeth did not appear to track as well on the ungalvanized W-beam. These findings led the researchers to

conclude that the poor performance observed in Test BEST-7 was a result of the use of ungalvanized W-beam. A special stock of lengthened galvanized W-beam was obtained for the remaining tests, and this test was conducted again as test BEST-8.

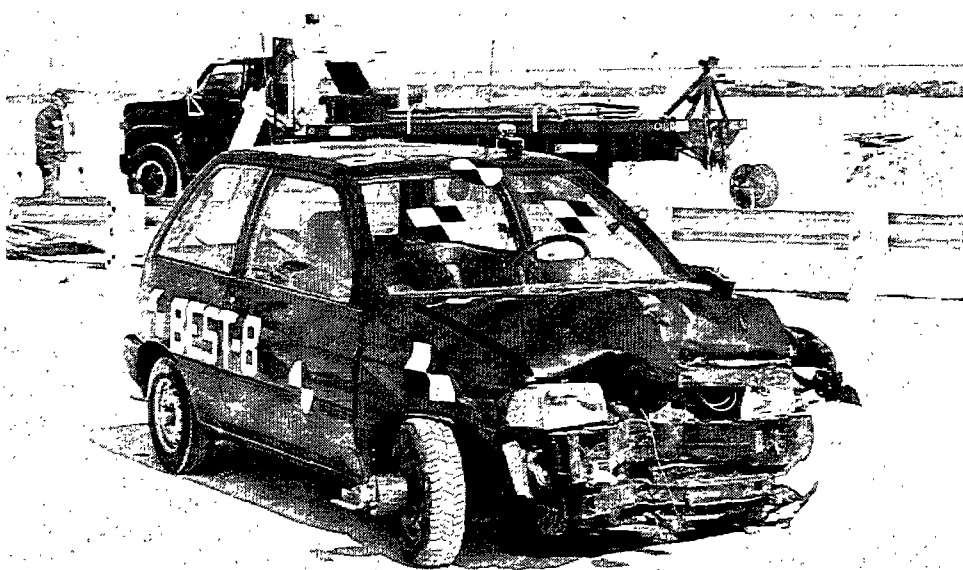
Figure 35. Vehicle Damage, Test BEST-8.

Damage to the vehicle was minimal, as shown in Figure 35, with 25 cm (10 in.) of crush on the front of the vehicle. The only occupant compartment deformation occurred on the driver's side floorboard, and the maximum deformation was measured to be 76 mm (3 in.).

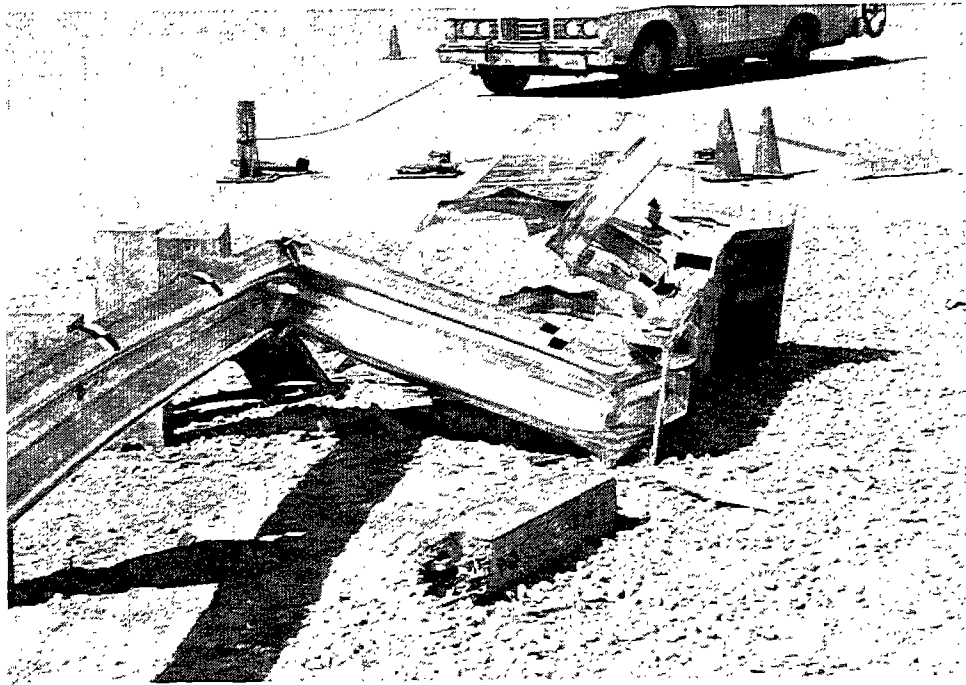
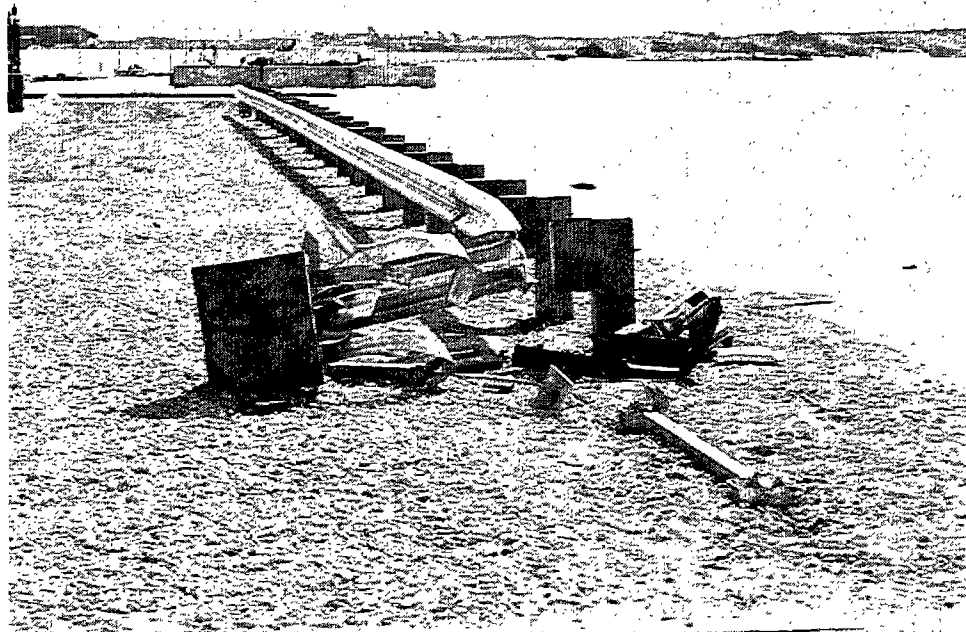
Figure 36. Installation damage, Test BEST-8.

Damage to the system, shown in Figure 36, consisted of posts 1 and 2 breaking cleanly at the top of the foundation tubes. Post No. 3 was pushed downstream slightly, with a 19 mm ($\frac{3}{4}$ in.) gap in the soil visible on the upstream side of the post at ground level. The W-beam rail was

buckled at the end of the chute and at the post no. 3 location.

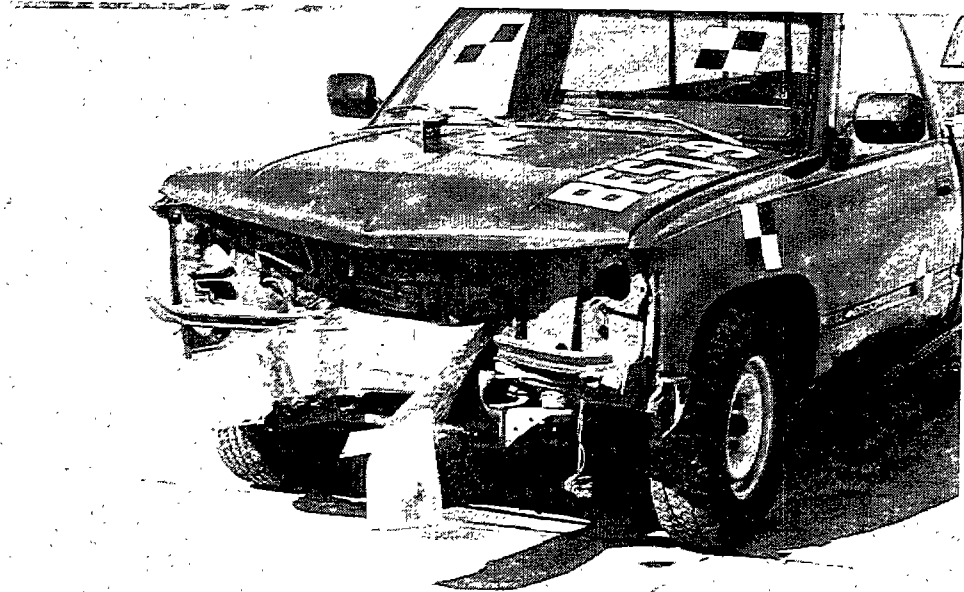
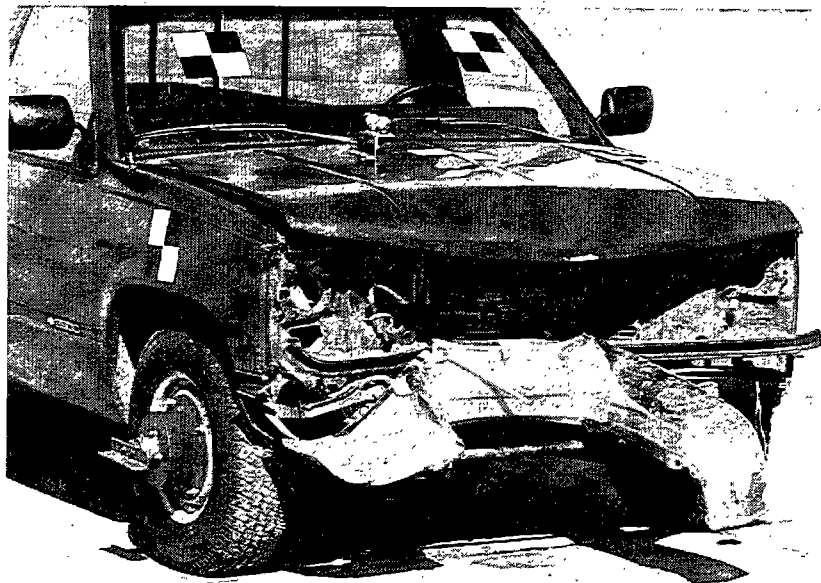
Figure 41. Vehicle Damage, Test BEST-9.

Damage to the vehicle was minimal, as seen in Figure 41. There was no visible occupant compartment deformation, and there was 29.2 cm (11½ in.) of crush in the front of the vehicle where the impact head contacted the test vehicle.

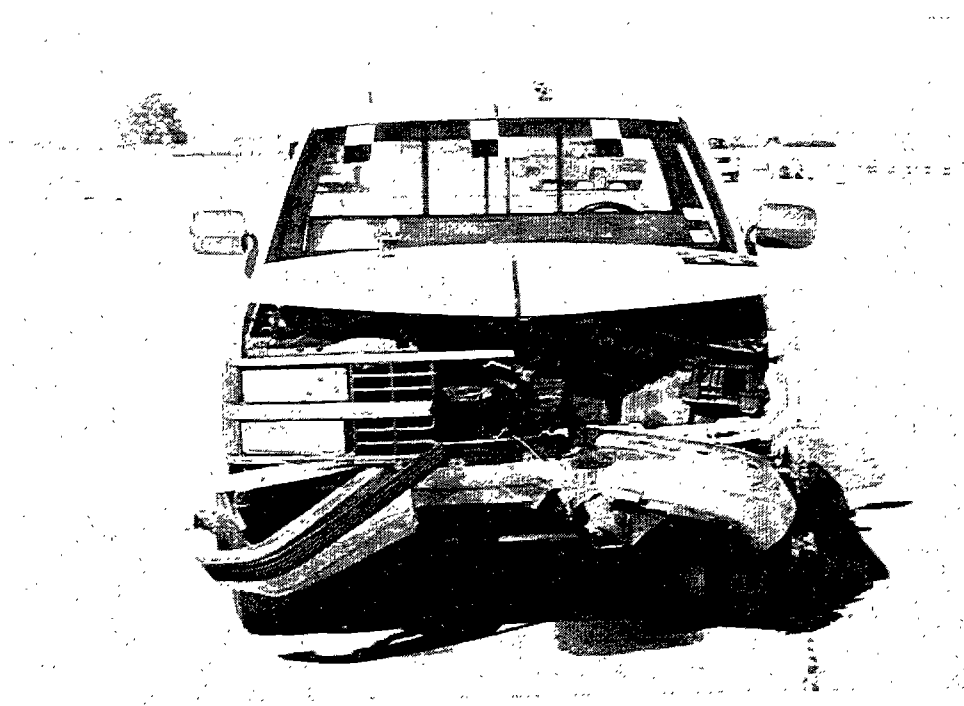
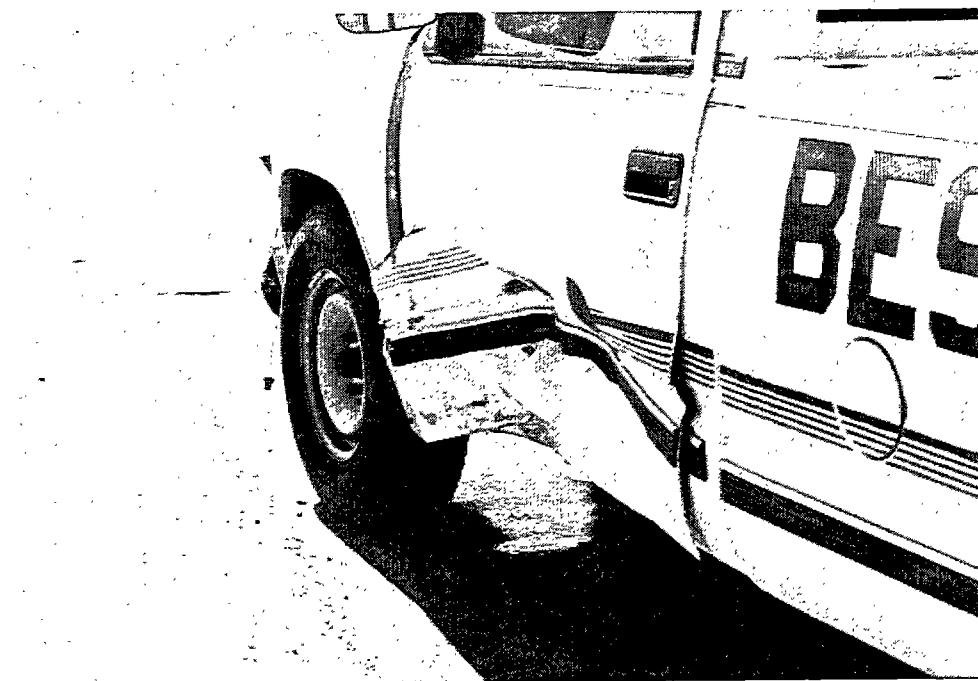
Figure 47. Vehicle Damage, Test BEST-10.

Damage to the vehicle was relatively minor, with 34.3 cm (13.5 in.) of crush in the front and no visible undercarriage damage. The driver's side door was damaged from contact with the impact head as the vehicle passed by it. This damage, shown in Figure 47, consisted of the tearing of the outer sheet metal and approximately 229 mm (9 in.) of crush on the outside of the door. This resulted in approximately 114 mm (4.5 in.) of deformation on the inside of the driver's door. There was no other occupant compartment deformation.

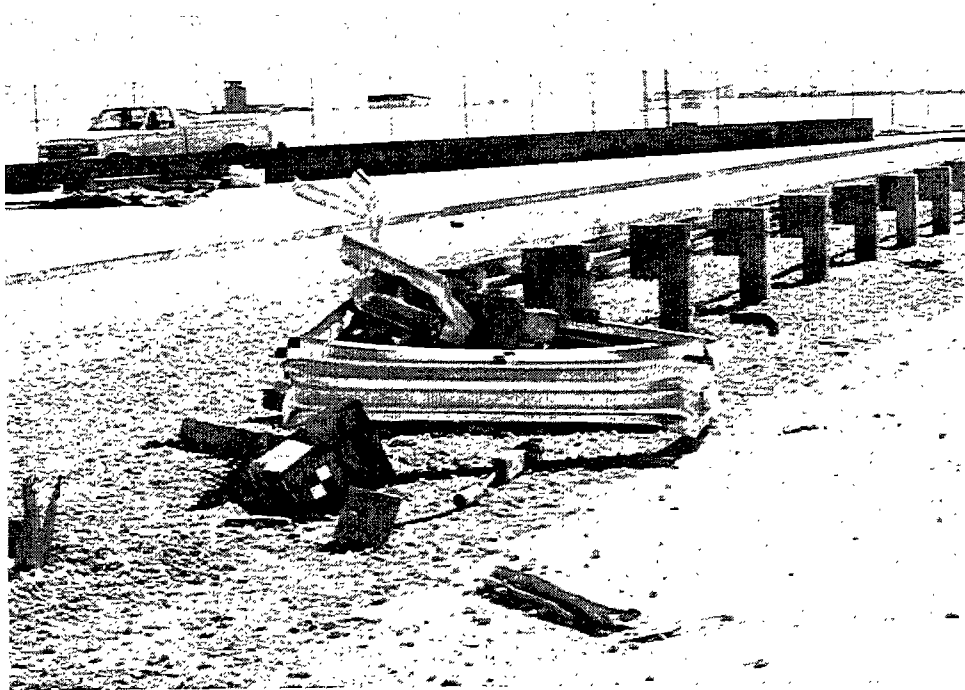
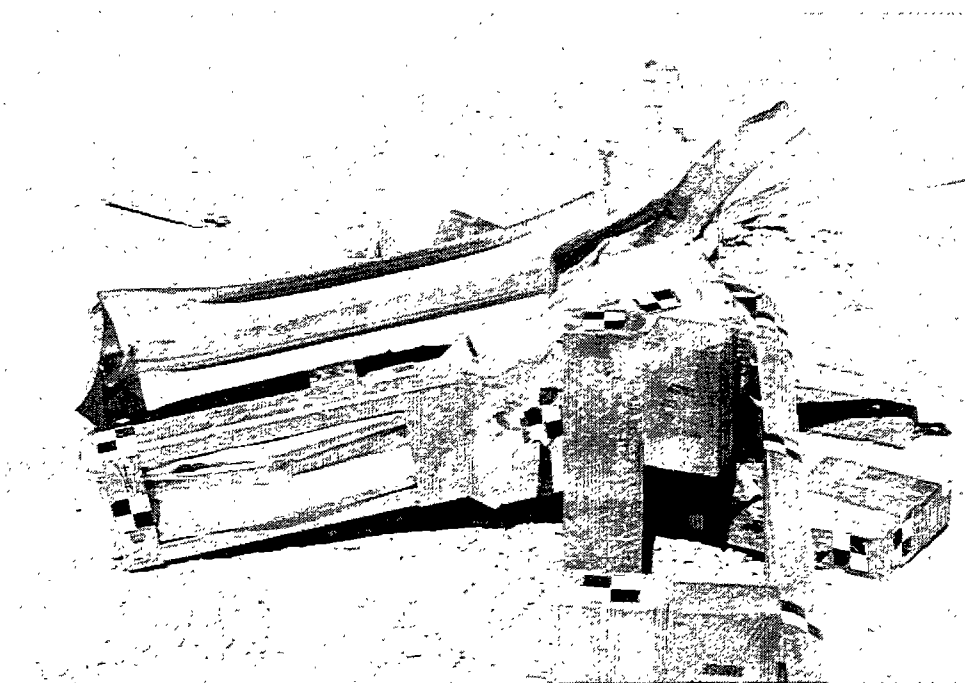
Figure 48. Installation damage, Test BEST-10.

Damage to the system can be seen in Figure 48. Post nos. 1 and 2 were broken cleanly

at the top of the foundation tube. Post No. 3 broke at the groundline CRT hole, while post No. 4 rotated more and broke at the bottom CRT hole. The system cut for a total distance of 2.16 m (7 ft - 1 in.), with buckling occurring at the end of the chute when it was 0.97 m (3 ft - 2 in.) upstream of post no. 3. The W-beam also buckled at post locations 3 and 4. Damage to the impact head consisted of deformation of the front plate where the initial contact with the test vehicle occurred.

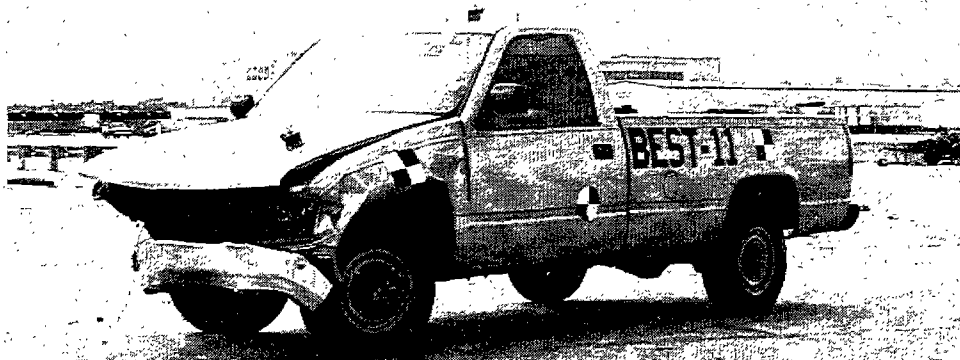
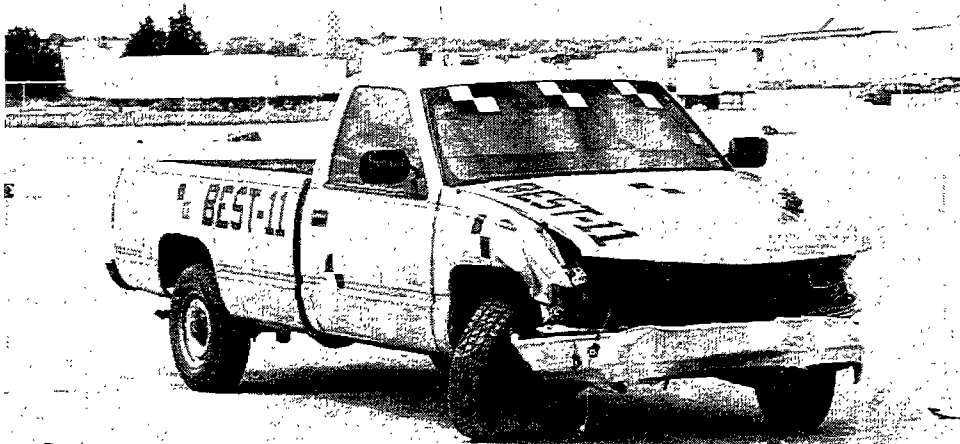
Figure 53. Vehicle Damage, Test BEST-11.

Damage to the vehicle, shown in Figure 53, consisted of crushing of the right-front quarter panel and failure of the front-right tie-rod which allowed the tire to rotate freely outward. All four tires remained inflated throughout the crash test and there were only minor contact marks along the passenger side of the vehicle. The manual transmission shifted as a result of the impact and caused slight damage to the center of the floorboard where the gear selector is located. There was no damage to the driver's side floorboard, but the passenger's side floorboard was deformed slightly, with a maximum deformation of 64 mm (2.5 in.). There was no damage to any of the

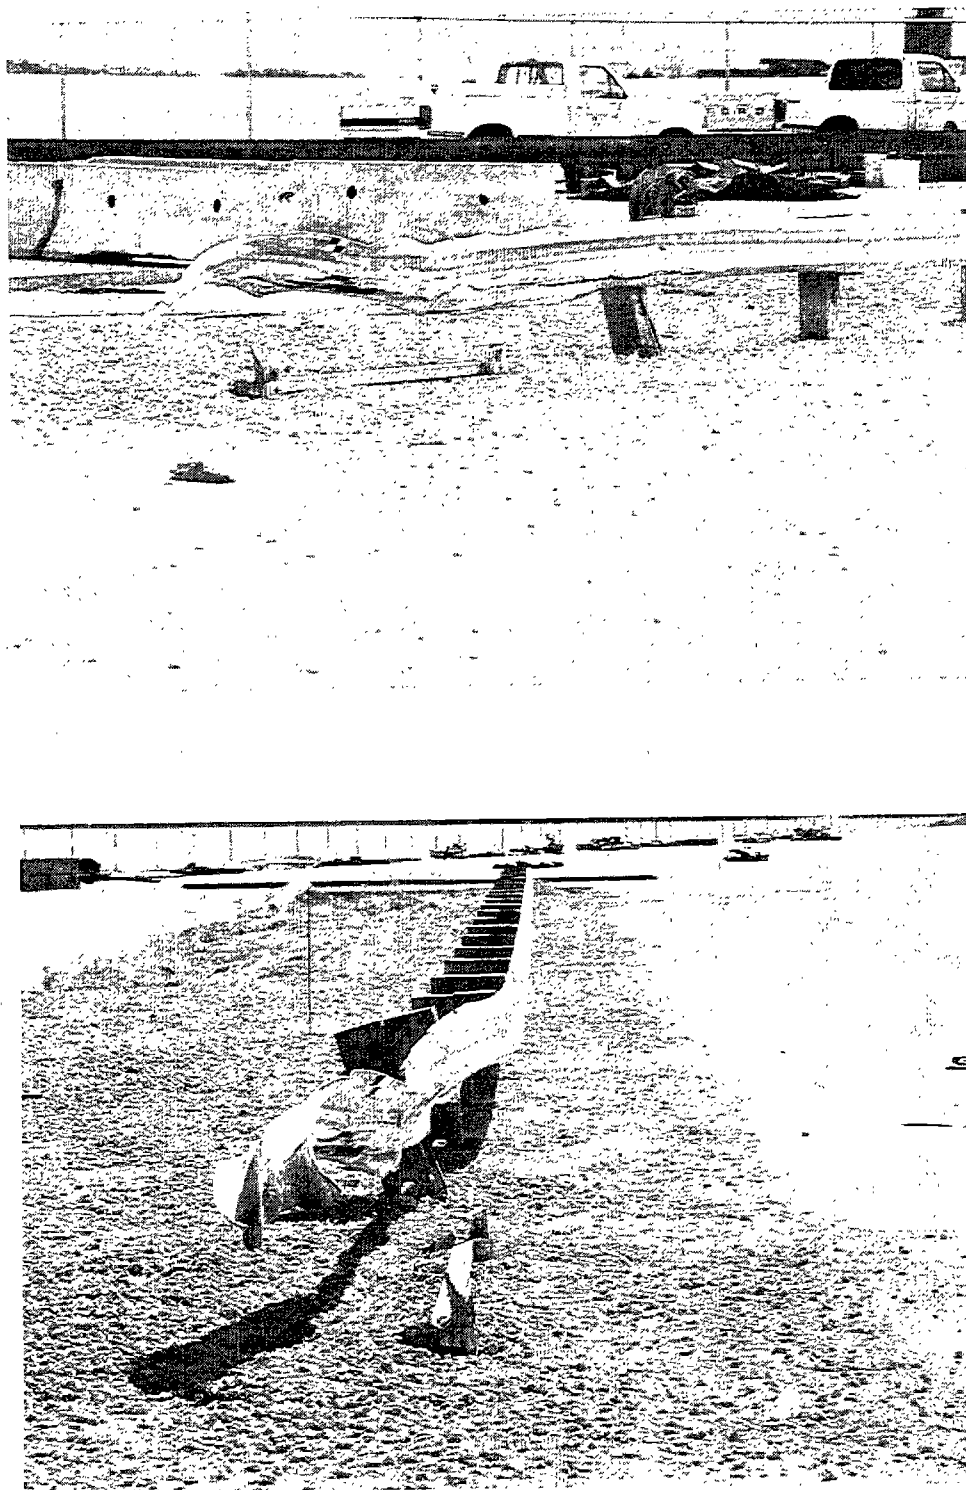
Figure 54. Installation damage, Test BEST-11.

Damage to the system, shown in Figure 54, consisted of post nos. 1, 2, and 3 breaking at the groundline and post no. 4 rotating slightly so that there was a 25 mm (1 in.) gap in the soil at the front of the post. The impact head was undamaged and there was some noticeable deformation of the cable anchor box. There was a 229 mm (9 in.) long tear approximately 51 mm (2 in.) from the bottom of the W-beam just below the bolt hole location for post no. 2.
